Case Study:

Lateral Malleolus Fracture: Delayed Fixation with Mg OSTEOCRETE Bone Void Filler

Manufactured by Bone Solutions, Inc., distributed by Alliant Biotech, LLC.
www.alliantbiotech.com
888-307-1144

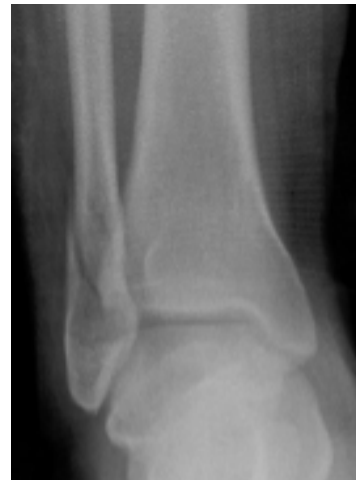
Fig 1A Radiographic image at initial presentation

A 48-year-old female presented with a lateral malleolus fracture after tripping. Patient initially did not want to have surgery and chose to attempt conservative management. After 10 weeks of non-weight bearing and immobilization, no signs of fracture consolidation were visualized radiographically. An MRI was ordered and images showed incomplete osseous bridging across the lateral malleolar fracture site and incomplete healing of the syndesmosis.

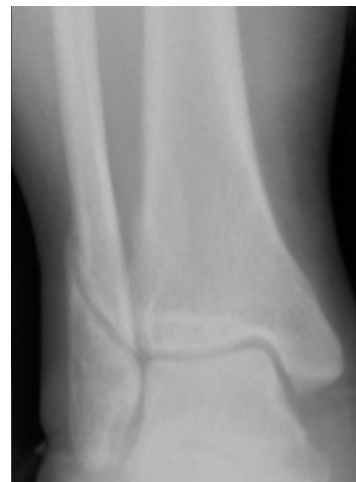
Fig 1B Radiographic image after 10 weeks of conservative management

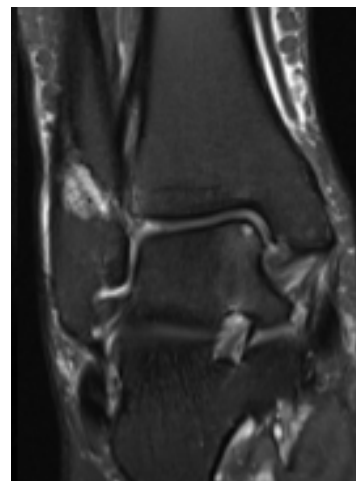
Fig 1C MRI delayed healing of the lateral malleolus fracture

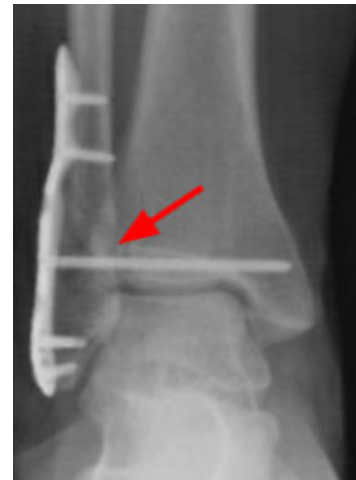
Fig 2 Immediate post-op radiographs demonstrating presence of Mg OSTEOCRETE Bone Void Filler with lateral malleolar fracture fixation and syndesmotic screw fixation

Standard lateral malleolar open reduction approach was performed. The fracture line was recreated using an osteotome and mallet. Once the fracture line had been completed and the capital fragment was freed, a large defect remained once reduction had been achieved. With this free space between the fragments being too wide to heal, 5cc of Mg OSTEOCRETE Bone Void Filler was utilized to fill the gap. Mg OSTEOCRETE Bone Void Filler was prepared until it reached a paste-like consistency and was applied within the fracture fragment site that had been created. Fixation was then implemented, and anatomic reduction of the ankle joint was achieved.

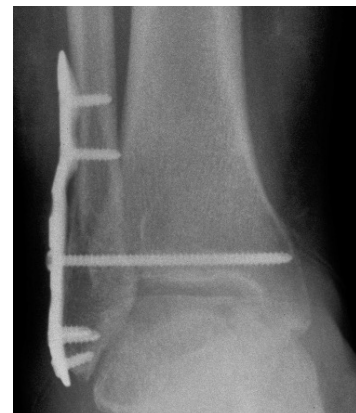
Fig 3 Radiographic image 10 weeks post-op

The patient fell and twisted the operative extremity during the post-operative period. This resulted in the patient being non-weight bearing for 10 weeks.

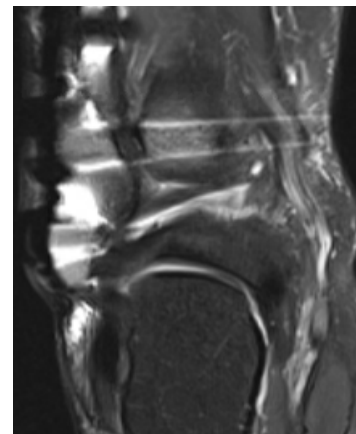
Fig 4 MRI was limited due to metal artifact, but ongoing healing was confirmed given lack of fracture gap formation and remodeling at site of bone graft placement

Due to the patient experiencing a fall and having some ankle discomfort, an MRI was ordered 12 weeks post-operatively to ensure there was healing across the fracture site.

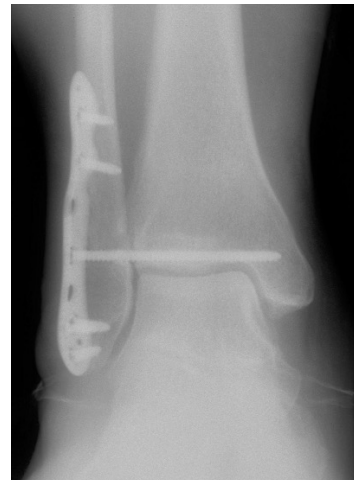
Fig 5 Radiographic image 9-months post-op demonstrating a healed lateral malleolus fracture

At the patient's 9-month follow-up, the patient had no pain and radiographic images showed Mg OSTEOCRETE resorption and complete osseous remodeling across the fracture site. The patient was now able to perform daily acts of life pain-free.
